Manhole Inspection Summary

Manhole # S31GG1008MH

Location Address: **221 STONEYFORD RD**

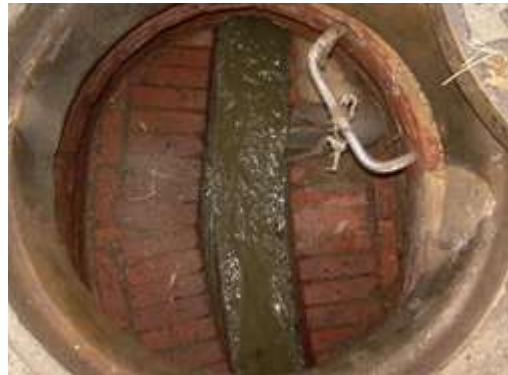
Top View

☒ **Debris** (not Condition related)

☒ **Evidence Of Surcharge**

Depth: **1.5** (ft.)

Evidence of surcharge - Bench debris.

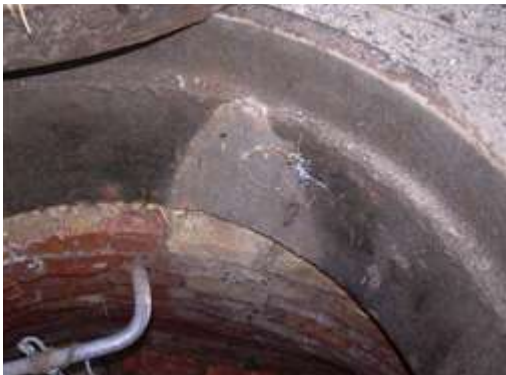
Defect

☒ **Leaks**

Infiltration: ☐ None ☒ **Joint** ☐ Cracks ☐ Mortar ☐ Roots ☒ **Wall**

Infiltration: ☐ None ☐ Joint ☐ Cracks ☐ Mortar ☐ Roots ☒ **Wall**

Frame leaks. Corbel and Barrel infiltration - other side.

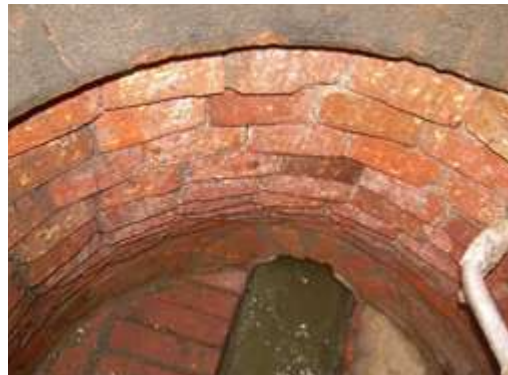
Defect

Frame leaks. Corbel and Barrel infiltration.

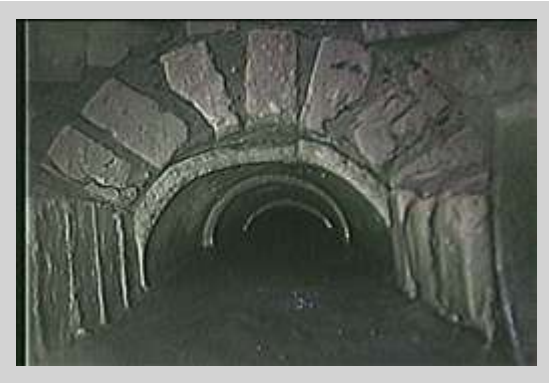
10 in. Circular Gravity Sewer Pipe Out @ 12 O'Clock

Condition: ☐ Sound ☐ Cracked ☐ Root Intrusion ☒ **Deteriorated** ☐ Leaks ☐ Debris

Channel deterioration.

Infiltration: **Evidence** Pipe Seal Cond: **Broken**

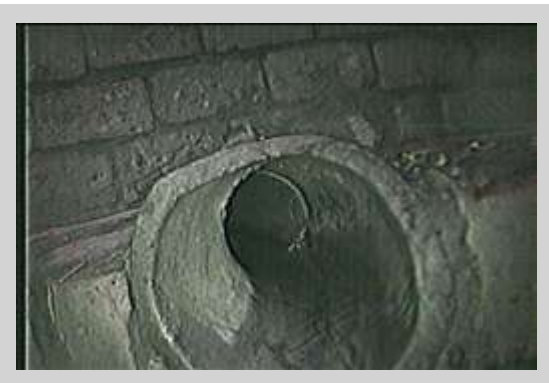
6 in. Circular Gravity Sewer Pipe In @ 3 O'Clock

Infiltration: **None** Pipe Seal Cond: **Cracked**

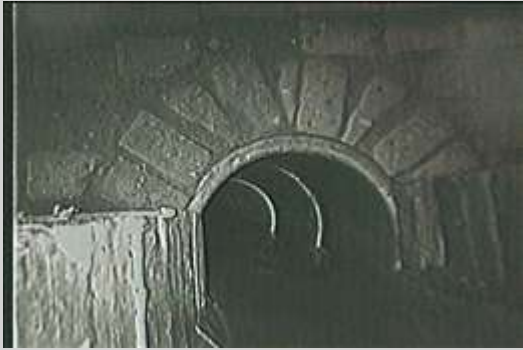
10 in. Circular Gravity Sewer

Channel deterioration.
